**Facility:** 25 Grosvenor  
25 Grosvenor  
Toronto, Ontario

**Date of Last Inspection:** May 7, 2003

**Type of Building:** Offices

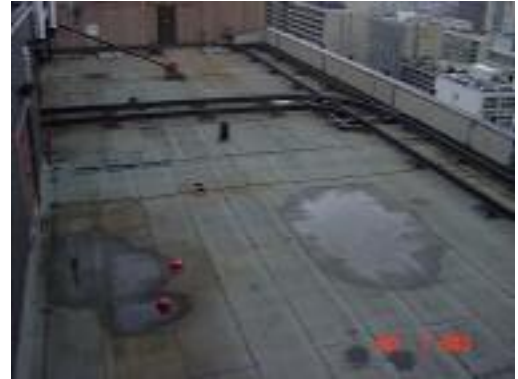
Photo	Date	Description
 	May 7, 2003	Core cut #1

Phenolic insulation saturated.
